HAMBLE
MARINE
SURVEYS

Pre-Purchase Survey

4th March 2016

Lying ashore Hamble Point Marina, 4th March 2016, for the purposes of a
Pre-Purchase Survey.

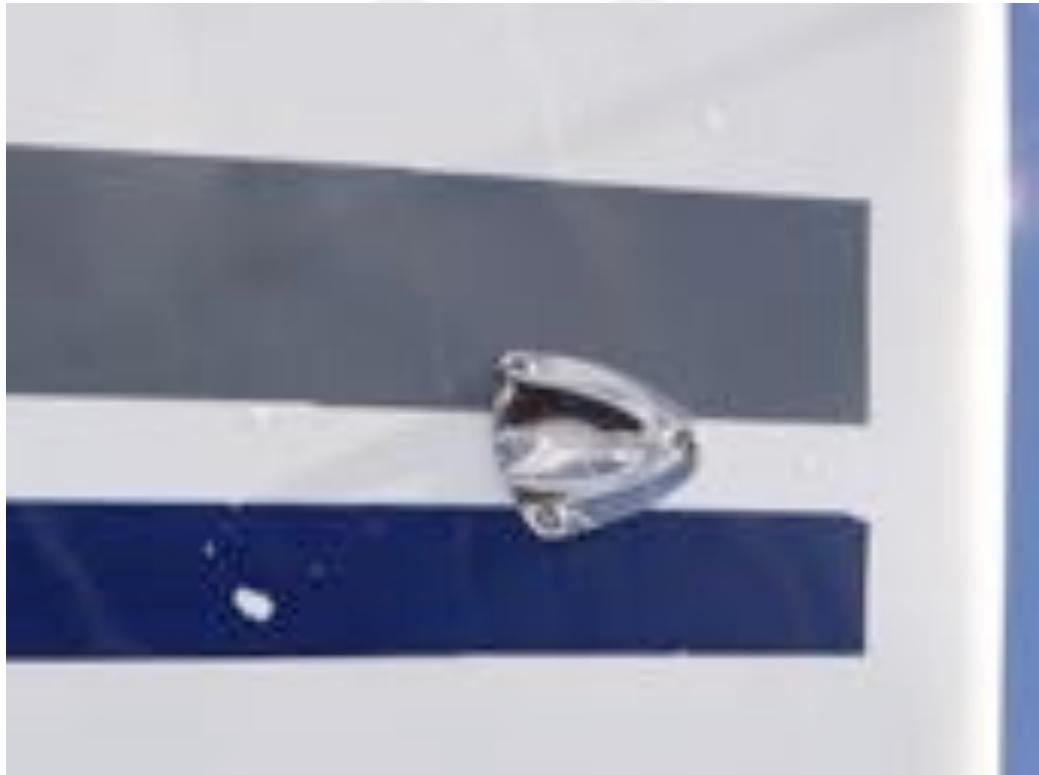
On the starboard side of the topsides the stainless steel water deflector for the chain locker drain is deformed and will need replacing.

Image of the starboard chain locker drain deflector, noted deformed.

1. *It is recommended that the topsides be further polished and gelcoat repaired where visible scratches remain. The bow protector if desired could be removed for repair or replacement for cosmetic reasons. The starboard chain locker drain deflector will need replacing as it is deformed. The decals will need repairing where damaged. (B)*
2. *It is suggested that consideration be given to replacing the transom rubber strip as it is badly marked and scuffed. (C)*

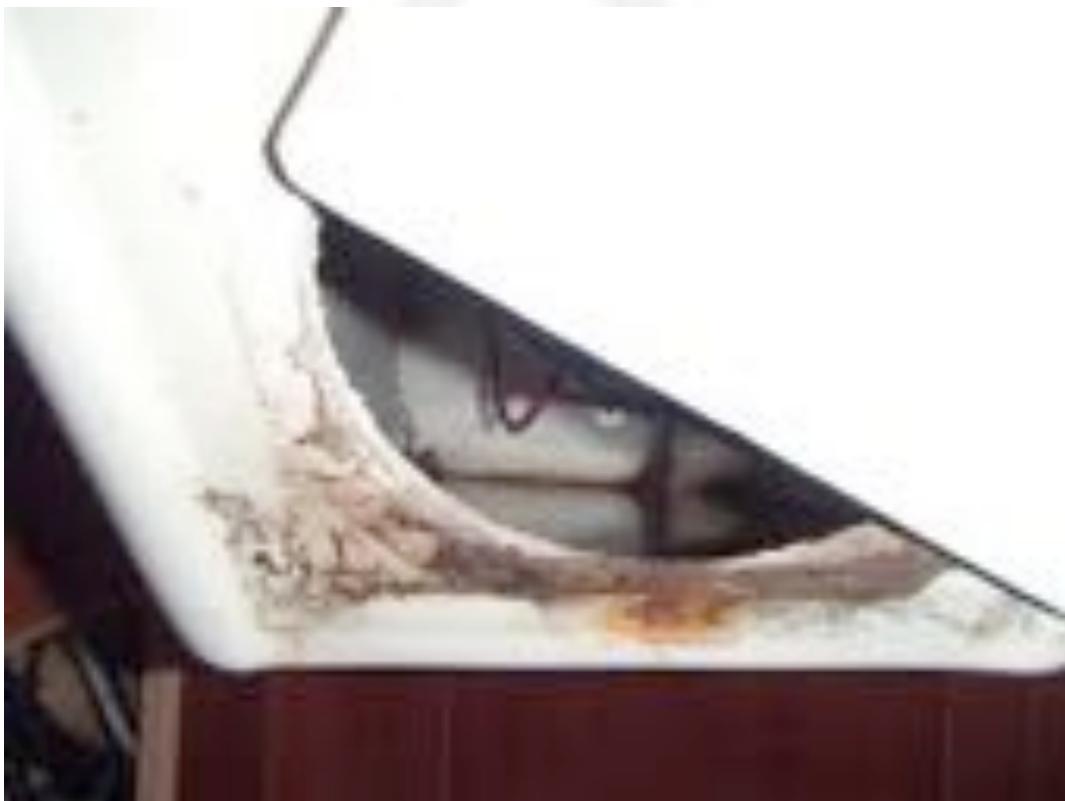
The moulded binnacles to each side of the cockpit were inspected. On the starboard side the underside of the binnacle was inspected via the aft cabin. The cushion was noted damp. Closer inspection reveals that the lower portion of the moulding under the pedestal has collected water. The source of the ingress is likely to be from around the compass.

Image of a inspection panel removed on the underside of the starboard binnacle accessible form the starboard aft cabin. Note the water pooling at the base of this moulding.

Both binnacles should be inspected and the leak on the starboard side rectified, the water that has collected removed and the cabin cushion dried.

1. *It is recommended that the leak from the starboard steering binnacle be located and rectified. The water that has collected at the base of the binnacle will need removing and the cushion removed for drying. As a precaution the port steering binnacle should be opened up and checked also. (B)*
2. *It is recommended that both steering wheels have their leather covering replaced as it is weathered, the steering cables all re-tensioned and the chain on the pilot motor also re-tensioned. (B)*

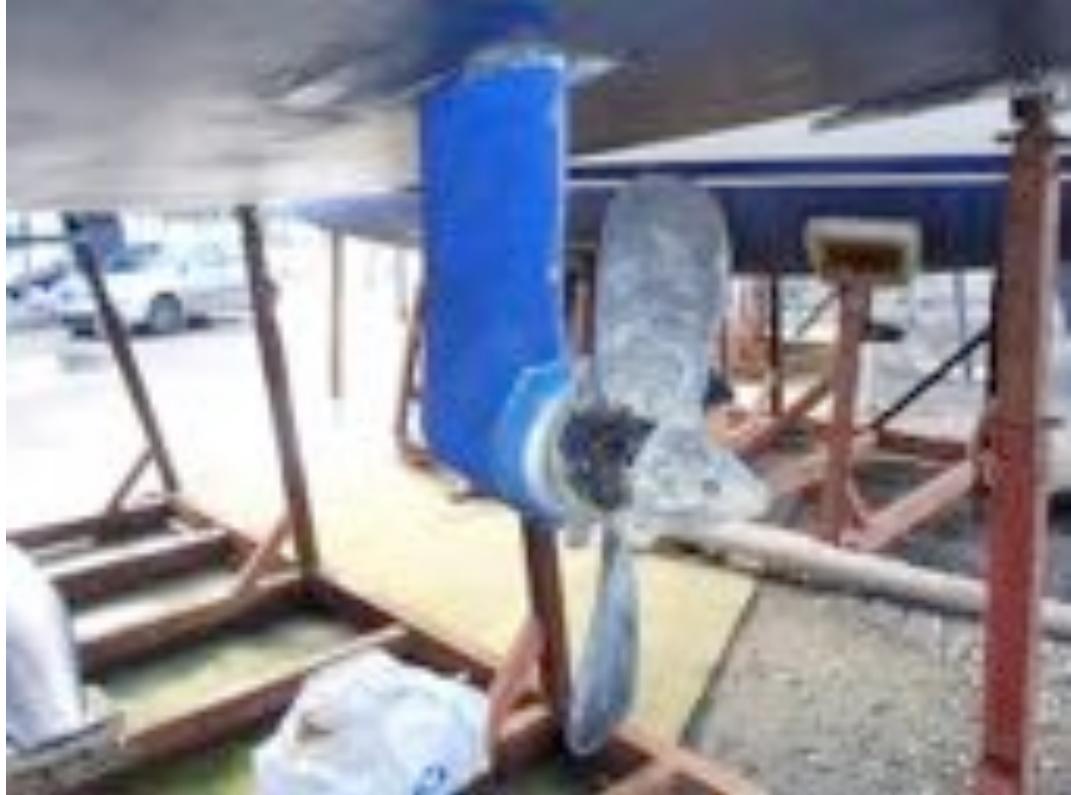
The 2 blade propeller is manufactured by Volvo Penta. The propeller was secure to the saildrive and without significant corrosion.

Image of the stern gear.

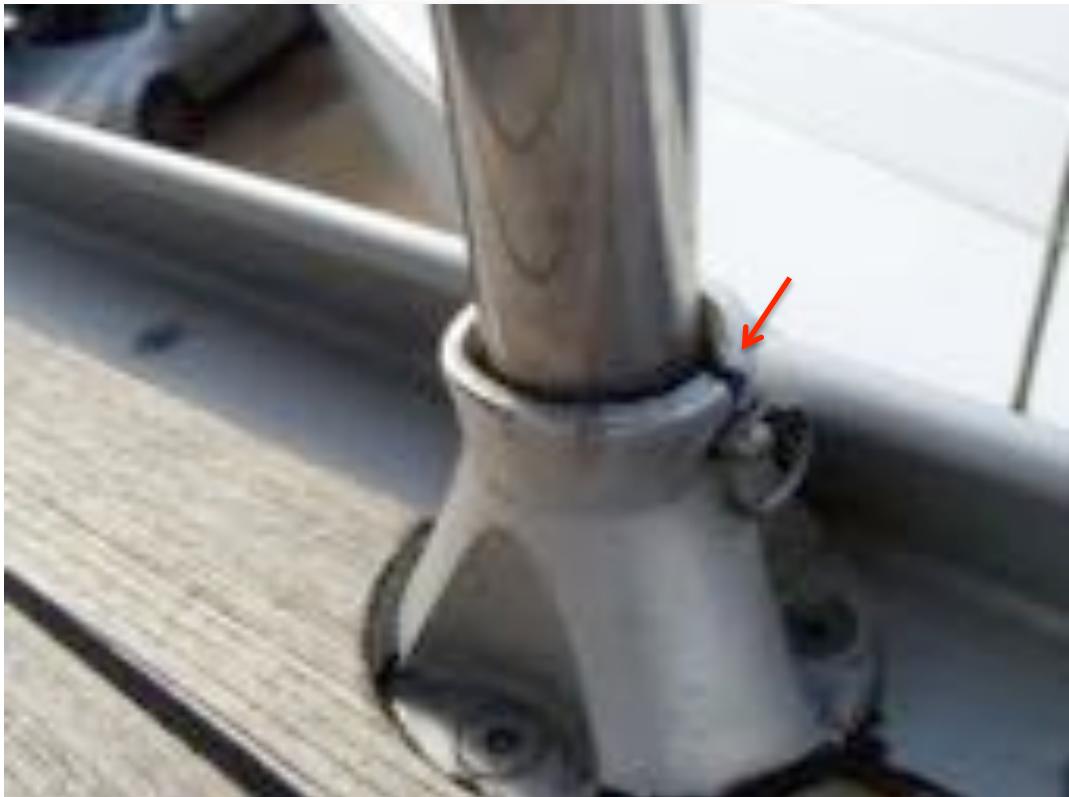
All stanchion posts were inspected. The two aft posts to port and the two mid posts to starboard are bent. The forward mid stanchion post base to starboard is cracked where the securing pin passes through the post base.

Image of one of the forward stanchion bases. Note the crack in the casting in way of the securing pin.

- 1. It is recommended that the bent stanchion posts all be removed for repair, and the cracked stanchion post base to starboard be replaced. (B)*

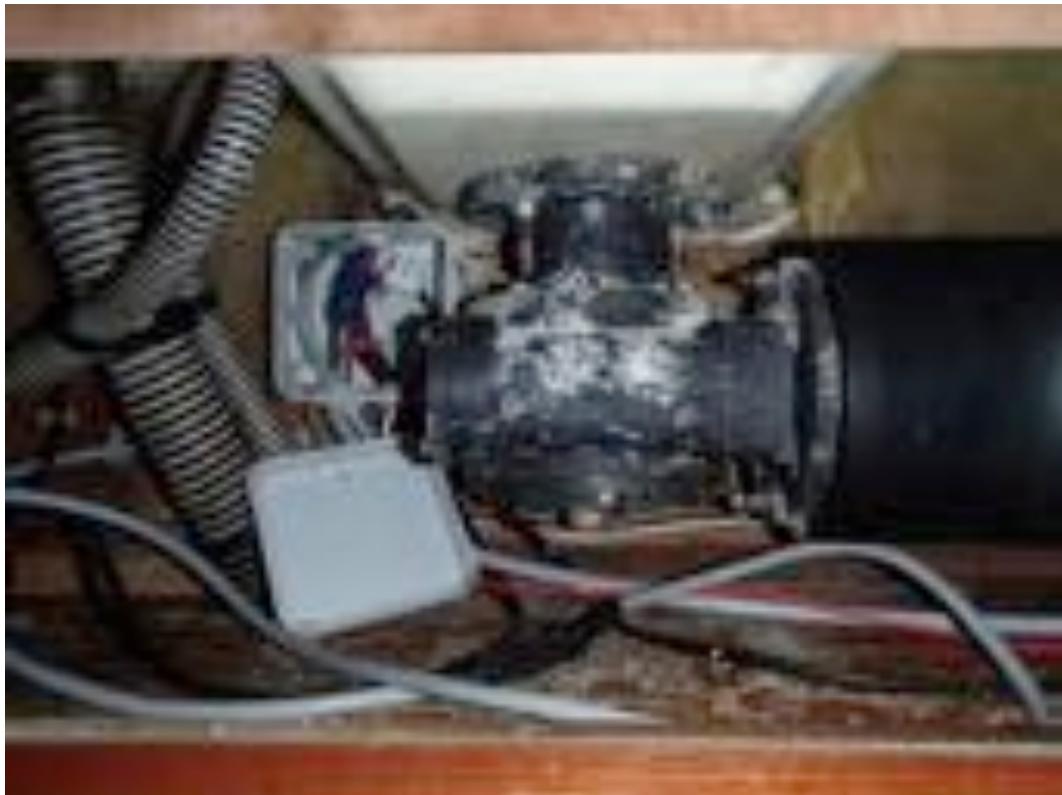
The windlass motor was inspected from underneath accessible from a high level cupboard in the forward cabin. The locker was damp and it is clear the windlass securing bolts have been leaking. The windlass motor is corroded externally.

Image of the windlass motor from in a cupboard at the front of the forward cabin. Note the corrosion over the motor evidencing water ingress.

It is likely that the windlass will need unbolting from the deck to permit the motor to be fully cleaned of corrosion, the chain guide and cover of the chain pipe will need to be re-instated, and the windlass re-sealed and secured back in situ. The windlass will need testing.

1. *It is recommended that the corroded chain that is visible be cropped or it may prove easier to simply replace all the chain. (B)*
2. *It is recommended that the windlass will need unbolting from the deck to permit the unit to be fully serviced and corrosion cleaned from the motor casing. The cupboard in the forward cabin will need cleaning out, and the missing cover and guide on the windlass re-instated. (B)*
3. *It is recommended that the hinges of the chain locker lid be re-secured. (B)*

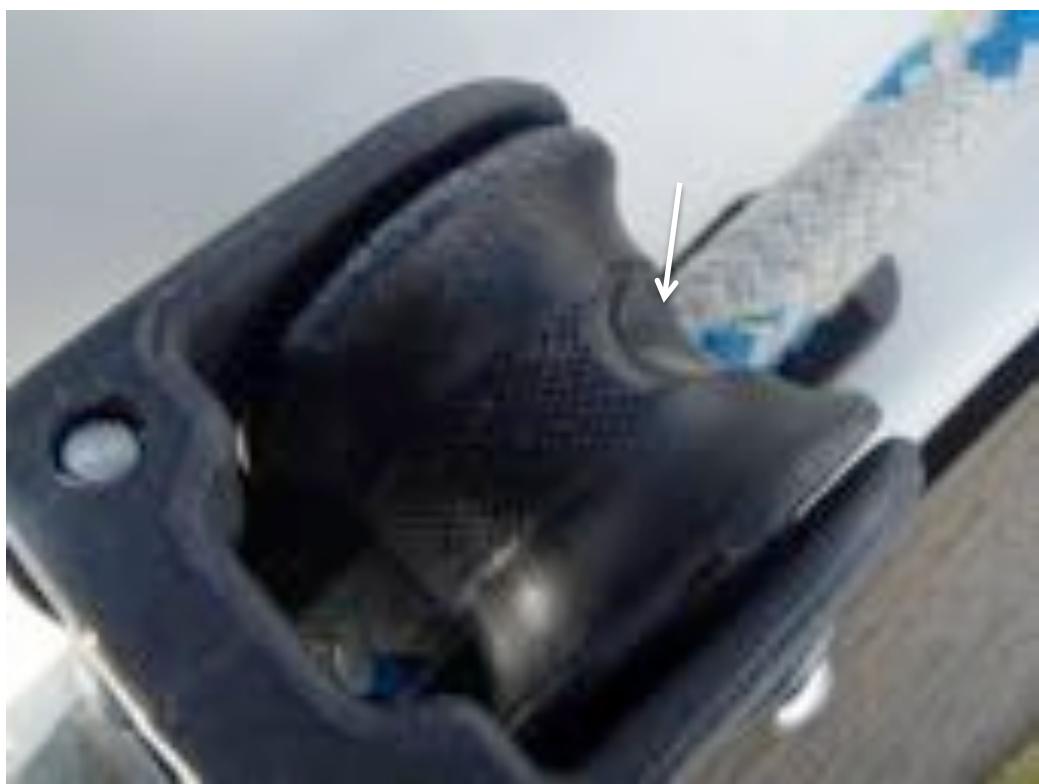
Image of the port side genoa turning block. Note the wear to the sheave.

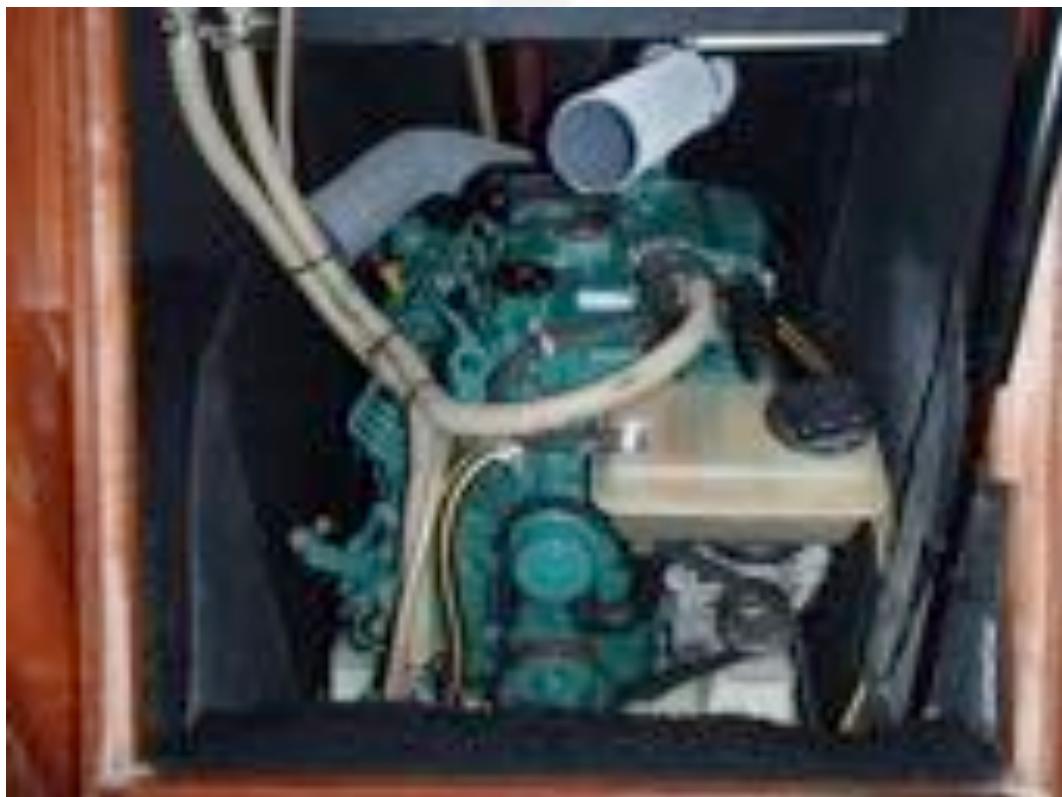
Image of the engine installation.

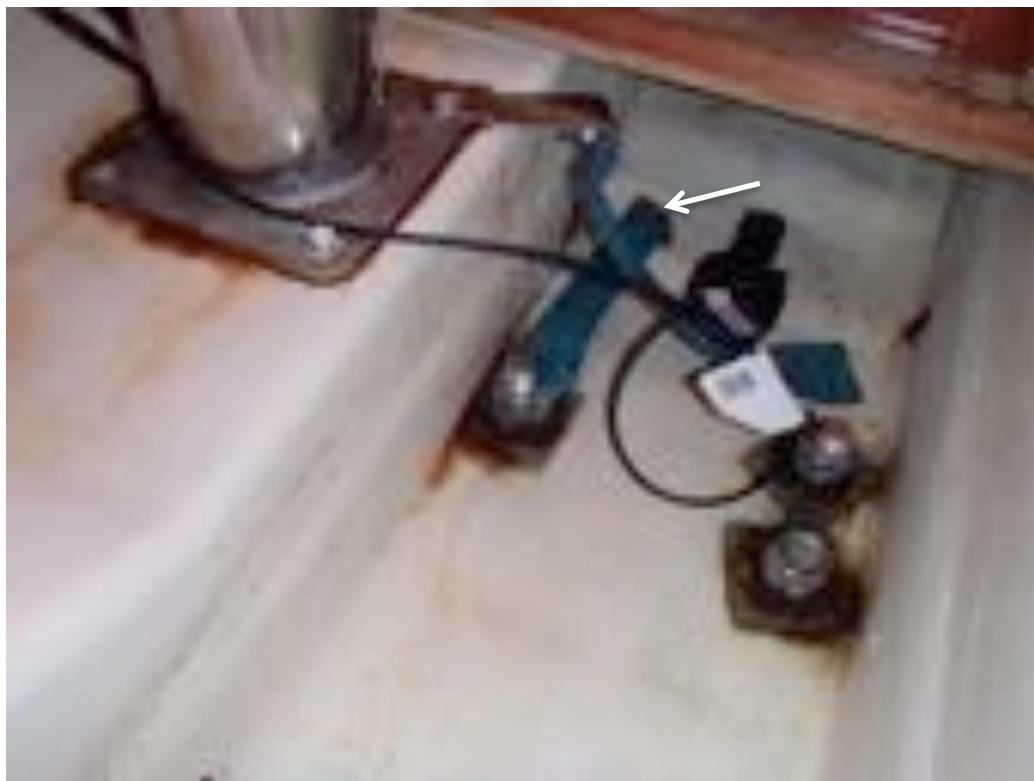
The mast is electrically grounded to the keel should the vessel be struck by lightening. The grounding cable is broken by virtue of the fact it is badly corroded.

Image of the forward bilge. Note the base of the compression post and green corroded grounding strap which has parted.
